Appendix D

Current and Predicted Stream Hydraulics for Stage 1 of the Mulloon Community Landscape Rehydration Project

Mulloon Community Landscape Rehydration Project

August 2017

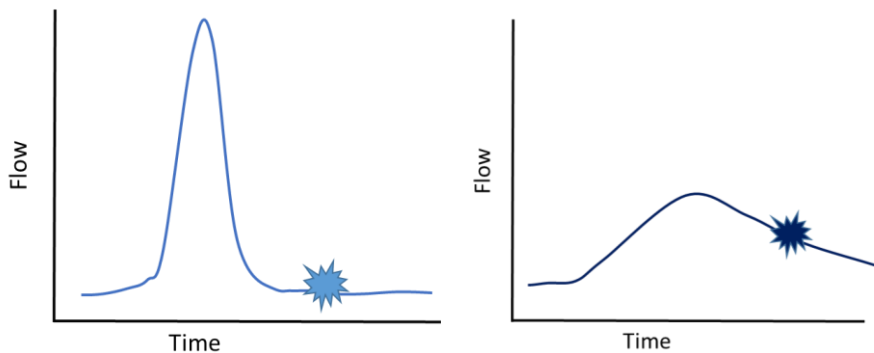
Figure 3 – Simulated flow duration curve pre vs post structure. Reduced peak flow (discharge) & elevated low flow.

Naturally, in every case *bank full discharge* reduces post-structure. Discharge reductions are most significant at the upstream and downstream most sites because of the significant reductions in the modelled velocity of the flow (see Figure 4). Roughly the same amount of water discharges, but due to reduced velocity, that volume discharges over a longer period of time (Figure 3).

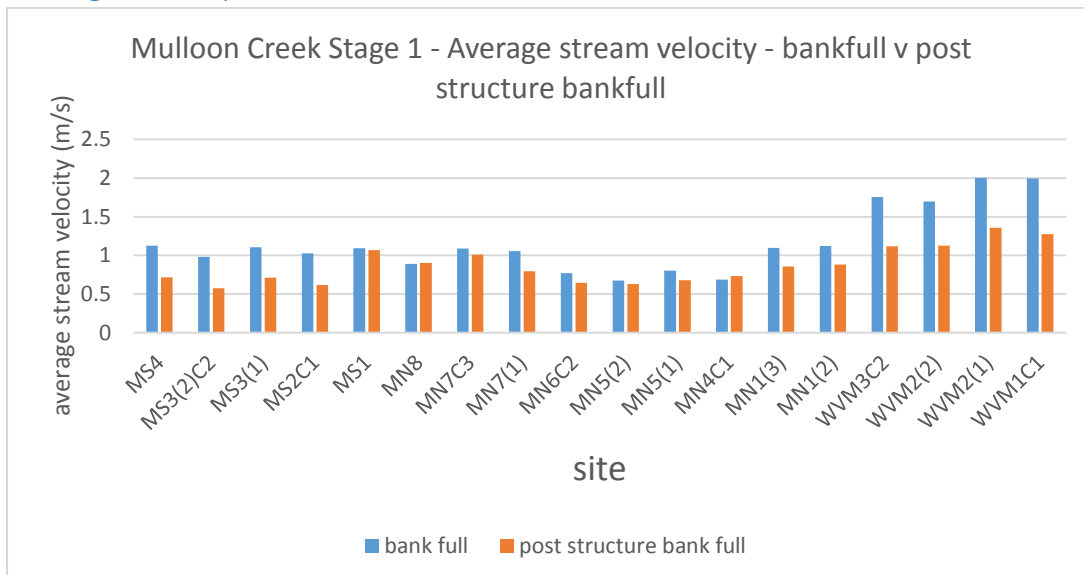
Figure 4 – Average stream velocity under current bank full compared to post structure bank full conditions.

Average *bank full* stream velocity is largely a function of stream gradient, surface roughness and the width/depth ratio of the stream. Average bank full velocity hovers around one metre per second until the flow passes through the most stable reach within Stage 1, which is MN6 to MN4, where the average velocity

drops to between 0.6 – 0.8m/s. This part of the system is the most geomorphically stable and ecologically complex reach throughout all of lower Mulloon.

Velocity begins to increase significantly from MN1 through to Kings Highway bridge due to increasing stream gradient and a significant reduction in surface roughness once the flow reaches WVM1.

At every site, with the exception of MN4, *post-structure* modelled average velocity reduces. In the case of the most upstream and downstream sites, which currently display the highest average velocities (2m/s at WVM1 & WVM2), the proposed structures create a significant reduction in the average stream velocity. This is because the proposed structures will reduce the average stream gradient, spread the flow over a greater cross-sectional area of the channel, and associated riparian fencing and revegetation will increase surface roughness.

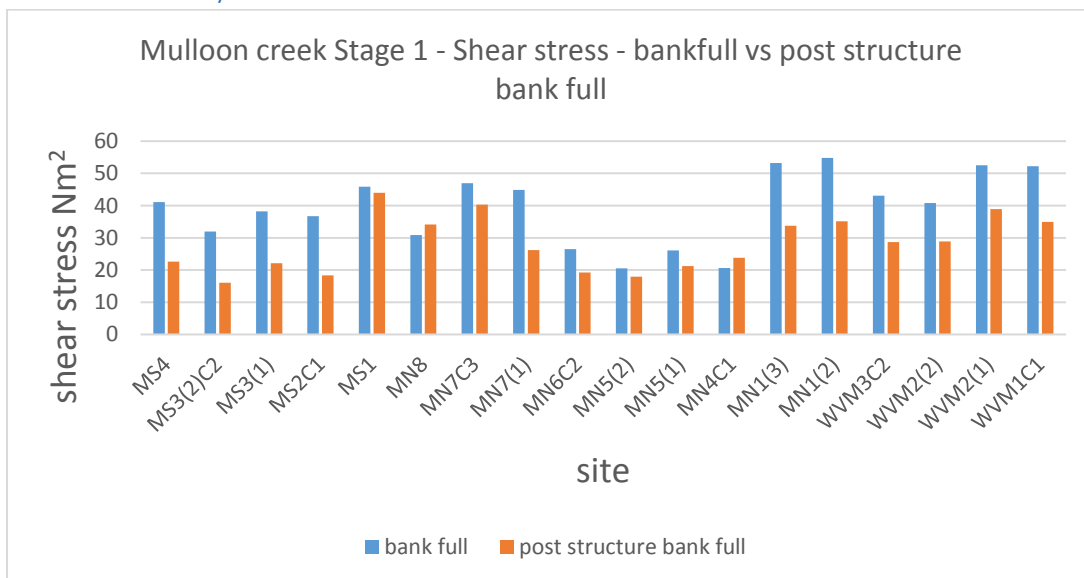
Figure 5 – Mean boundary shear stress under current bank full compared to post structure bank full conditions.

Along with unit stream power (Figure 7), mean boundary shear stress helps us understand the erosive forces at work on any part of the stream, and how that erosive force changes when any intervention, such as a bed control structure, is placed in the stream.

Figure 5 shows that the highest current mean boundary shear stress is at MN1(3) and MN1(2). It is no coincidence that adjacent to these sites during the high flow event of June 2016, a large hole was blown in the secondary channel (Figure 6).

At every site within Mulloon Creek Stage 1, whether or not a structure is proposed, mean boundary shear stress is predicted to reduce, which will lower the risk of erosion throughout the whole system.

Figure 7 shows a similar trend to Figures 2, 4 & 5. Unit stream power also begins to significantly increase downstream from MN1(3) as discharge, average velocity and mean boundary shear stress increase.

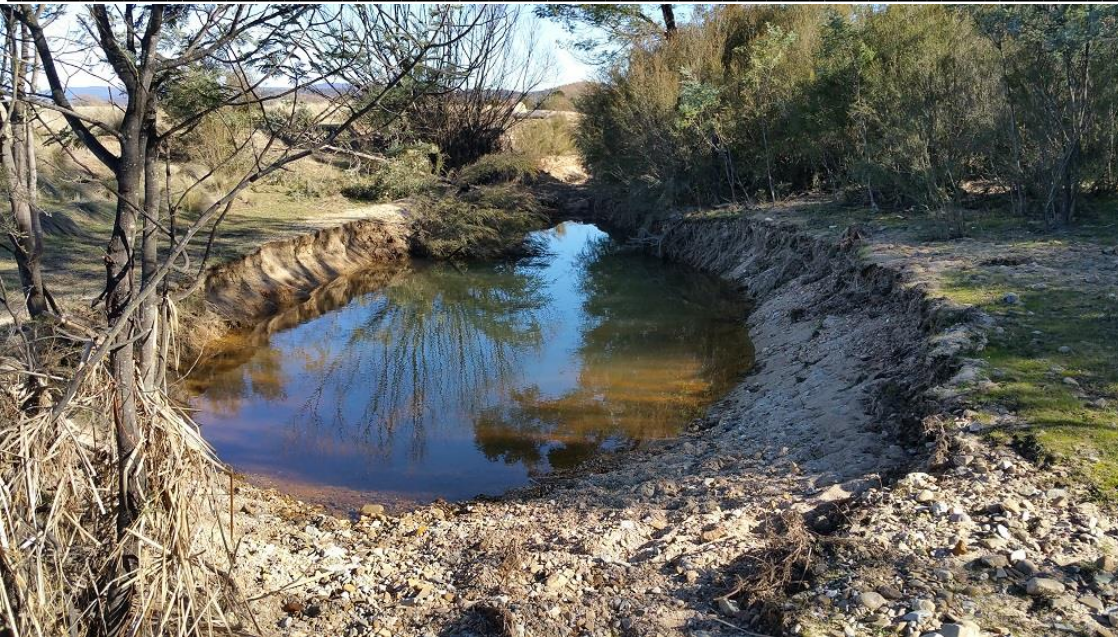
Figure 6 – Large hole blown in the secondary channel adjacent to MN1(2) and MN1(3) as a result of the June 2016 flood.

The log sills that were built at sites MN1 and MN2 led to very stable conditions upstream. But the increased gradient as a result of raising the streambed level and the continued low surface roughness conditions downstream of MN1, led to an increase in the stream velocity and consequent stream energy through this reach. This contributed to the secondary channel adjacent to MN1 being gouged out in June 2016 (Figure 6).

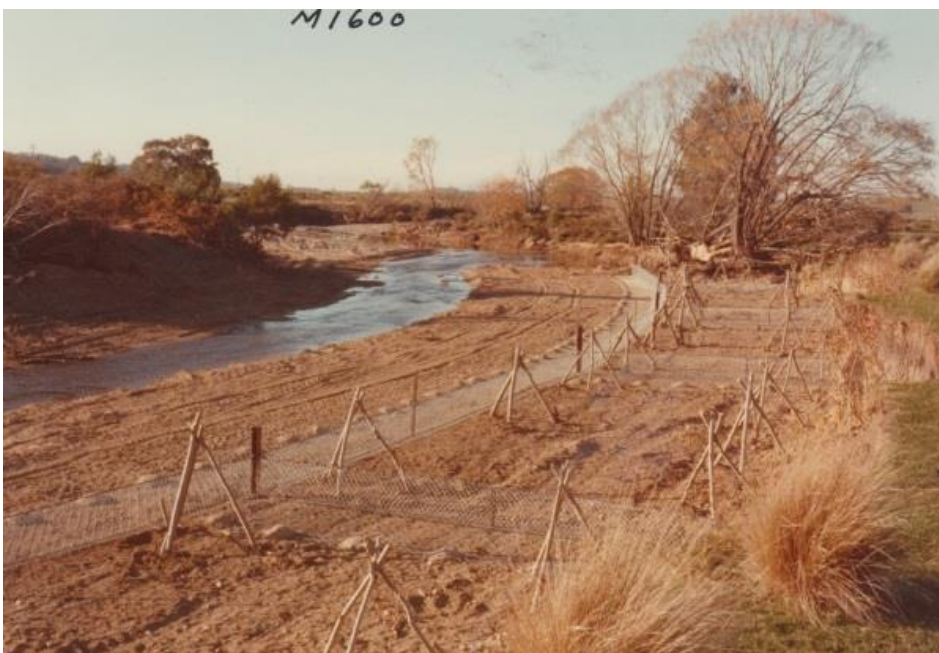
Figure 8 – One of many willow revetments constructed on the outside banks at Mulloon Creek between 1970 and 1980.

Interventions such as the willow revetment work in the 1970s (Figure 8), and the log sill work in the early 2000s, have influenced the energy flow through the system. The willow revetment work confined the high flows within a defined channel, so that the stream's energy was transmitted into the unconsolidated bed of the stream. This caused gouging of the bed in some cases by up to three metres. All these willow revetments are now undermined, some seriously (Figure 9).

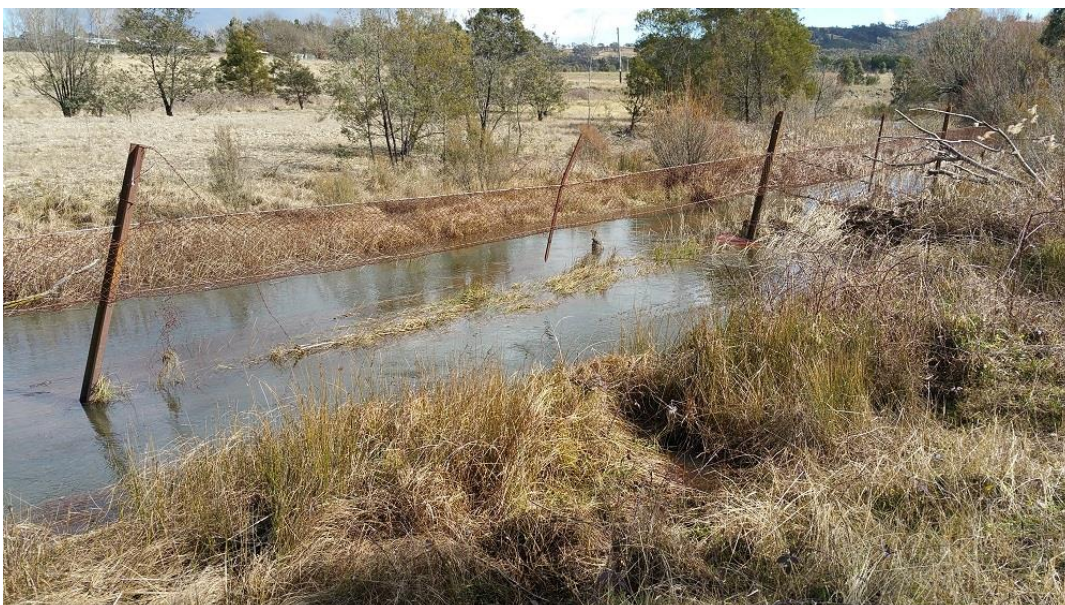
Figure 9 – In all cases, willow revetments constructed during the 1970s are now undermined.
