Mulloon Creek Fish Survey Autumn 2022

Final report to the Mulloon Institute
Centre for Applied Water Science
University of Canberra

Authors: Rhian Clear, Ben Broadhurst, Danswell Starrs and Mark Lintermans

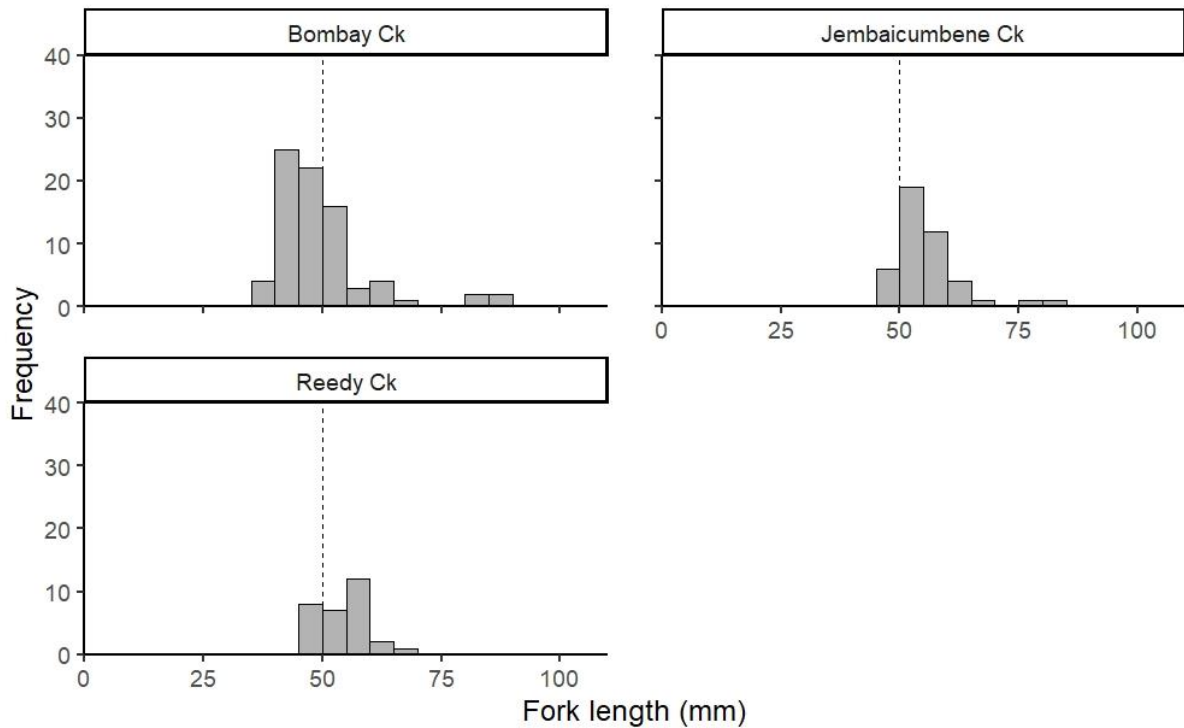
Figure 5. Length frequency of Mountain galaxias caught by backpack electrofishing from the three reference sites in June 2022. Dashed line indicates size at young-of-year (following O'Connor and Koehn 1991).

Mountain galaxias dominated the catch at all sites surveyed (Table 2 and Figure 3). Catch rates were highest at Bombay Creek closely followed by site 4 on Mulloon Creek (Table 2 and Figure 3). Fish ranged in size from 34 - 102 mm (FL) (Figure 4 and Figure 5). The most dominant size class overall was 40 - 65 mm (FL) (Figure 4 and Figure 5).

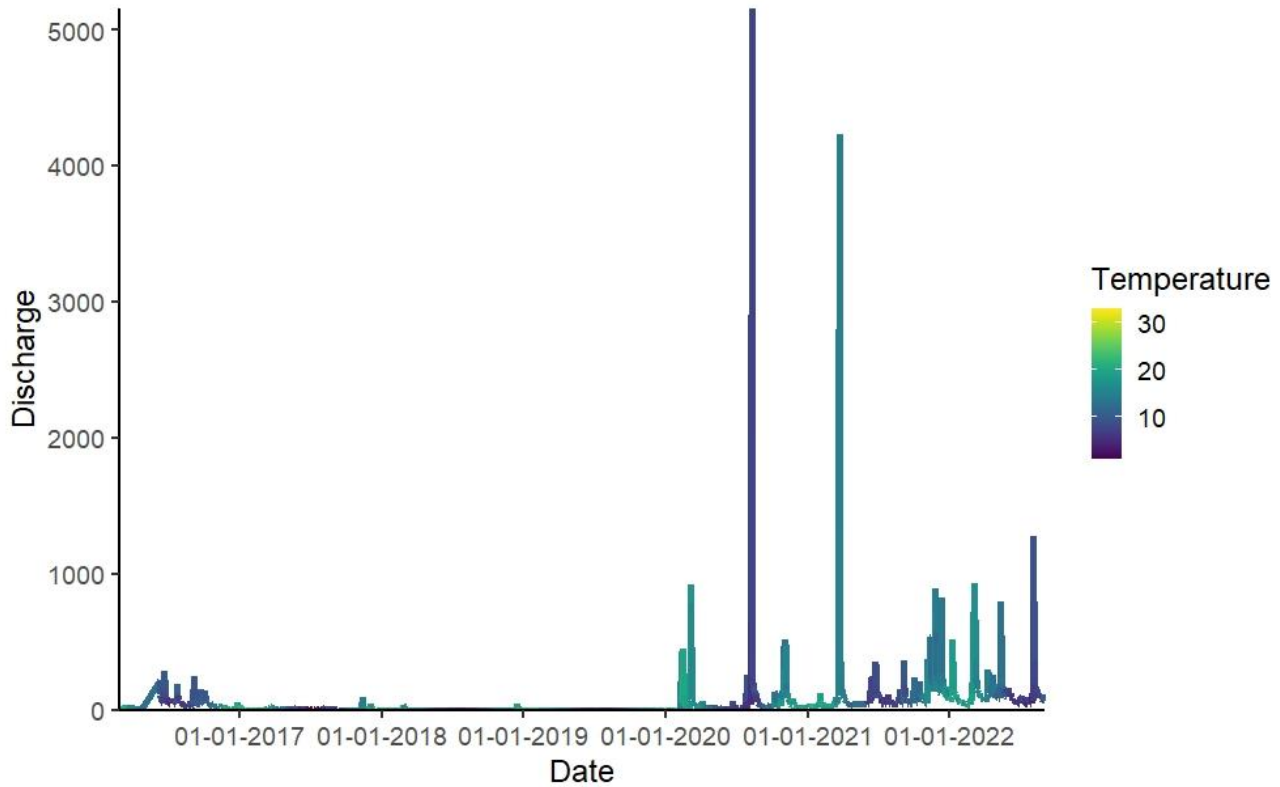
Figure 6. Daily discharge (ML/Day) and temperature of the Upper Mulloon Creek from March 2016 — September 2022.

Since the 2016 baseline survey, approximately 50 new leaky weirs have been installed along Mulloon Creek with a significant number proposed to be installed in the future (Figure 1). Further monitoring will enable a more in depth comparison to the baseline survey providing more understanding of the potential changes in the fish community.

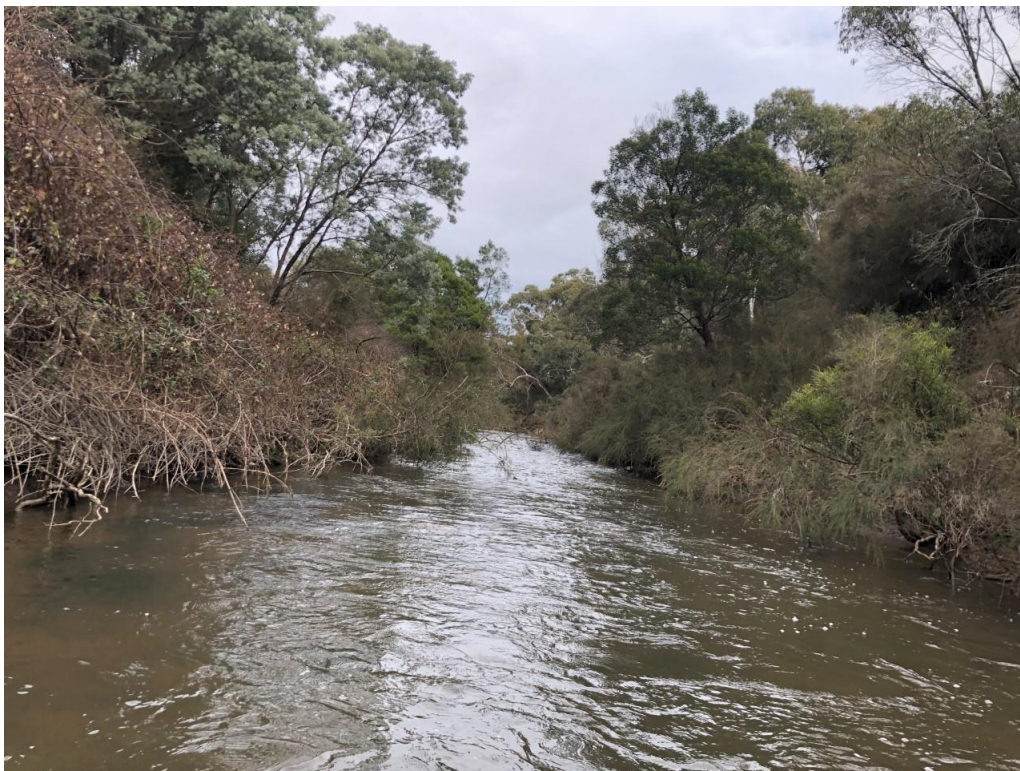
Mulloon Creek Site 1.

Description: The upstream-most site sampled on Mulloon Creek. This site occurs at the downstream end of a large tract of gorge country. At this point the creek is in a deeply (~15-20m) incised channel. Blackberries are the dominant riparian vegetation along this reach. Stream consisted of long pools, and short riffle sequences. The creek height was up and flowing faster at the time of sampling for all sites on Mulloon Creek.

Substrate Composition: Approximately 50% cobble, 25% sediment and 25% submerged vegetation. Small proportion was bedrock

Other Structure: Large amounts of drowned timber and large boulders and bedrock structures.

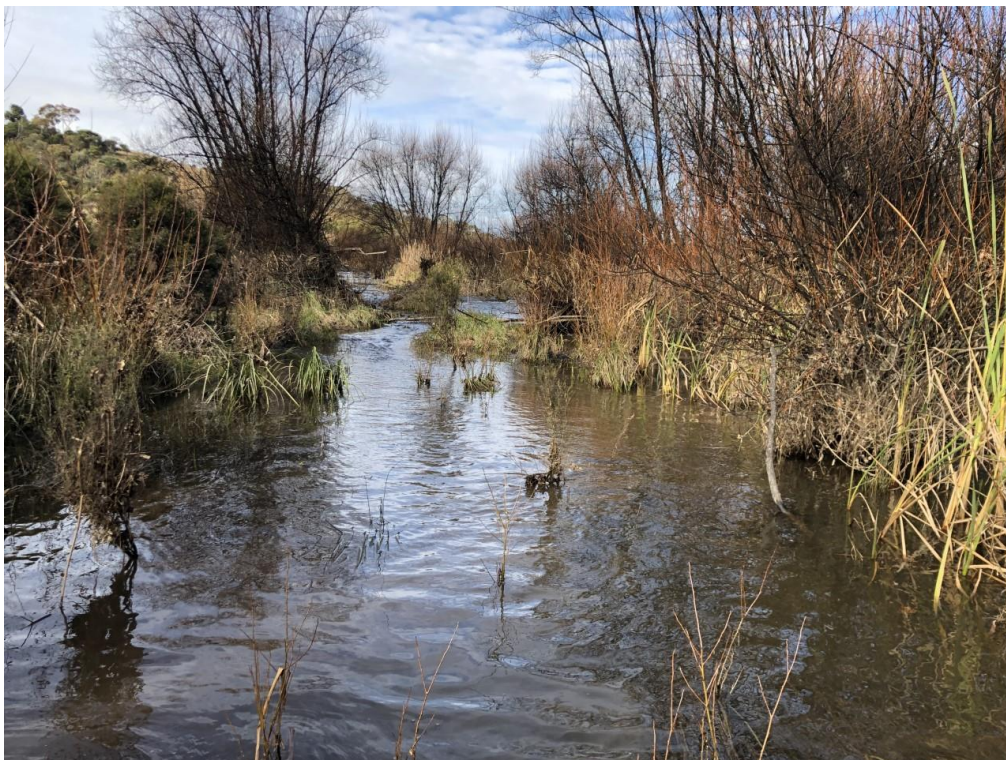
Mulloon Creek Site 2.

Description: The second site sampled on Mulloon Creek. This site occurs downstream of the homestead and is situated downstream of what was the first leaky weir in the system. It is now situated below an additional 10 leaky weirs since the first survey was conducted in 2016. The weir pool was sampled with the bait traps. Consisted of very long pools and runs, with very minimal riffle habitat. Willows are the dominant riparian vegetation. Considerable stands of tall emergent macrophytes present, and very dense submerged vegetation throughout this reach.

Substrate Composition: Primarily sediment and submerged vegetation. Very small amounts of cobble, with proportionally more cobble in the upstream riffle section of this reach.

Other Structure: Minimal structure in-stream. At upstream end larger cobble and boulders were present.

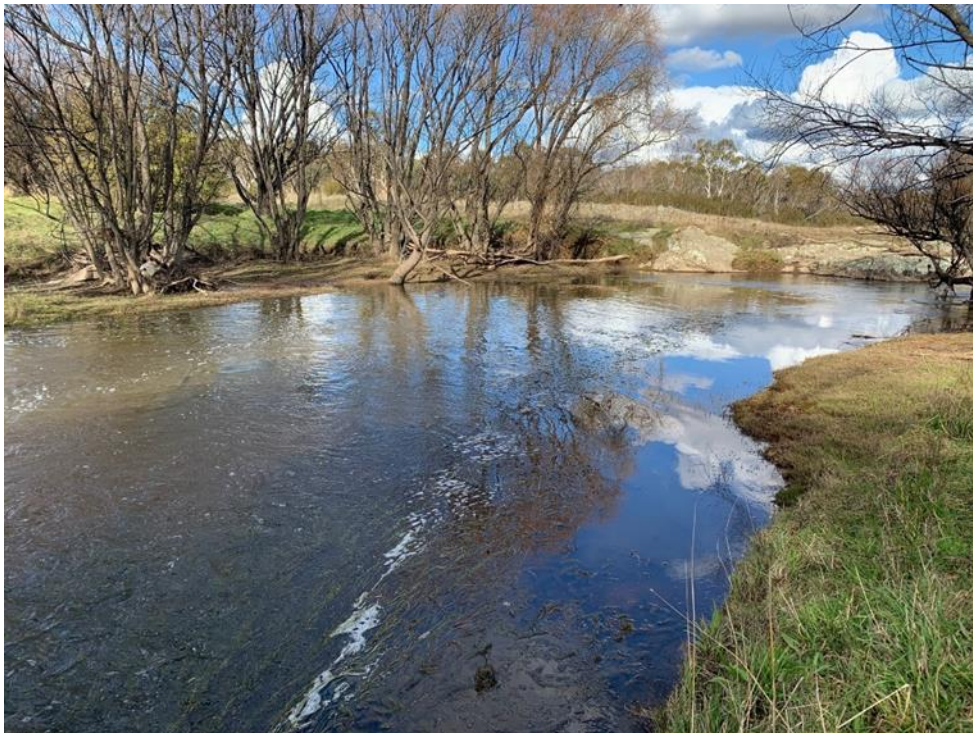
Mulloon Creek site 6.

Description: The downstream-most site sampled on Mulloon Creek. This reach occurs downstream of the confluence of Mulloon Creek and Sandhills Creek. The bait traps were set in the pool where the water quality station is located at the downstream end of this reach. Willows, blackberries and large stands of emergent vegetation dominated the riparian zone.

Substrate Composition: Consisted primarily of silt, sand and cobble and submerged vegetation.

Other Structure: A few boulders and significant fallen trees present at the top end of this reach.

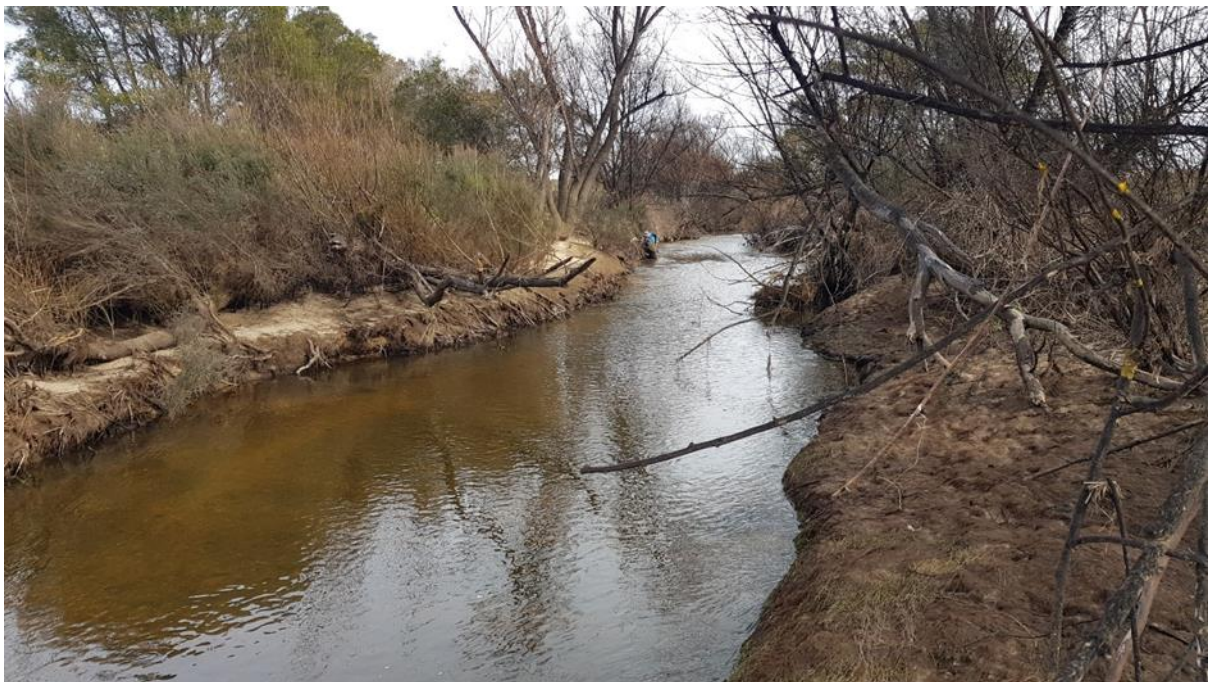
Reedy Creek at Mayfield Road crossing.

Description: This site occurs on the downstream side of the Mayfield Road crossing of Reedy Creek. This reach is heavily overgrown with native understorey, willows and blackberries. Channel is quite wide in places, but stream greatly restricted within this region. Flow was moderate at the time of sample and had recently receded after high flows from heavy rainfall.

Substrate Composition: Consisted primarily of cobble, sand and sediment.

Other Structure: Large amounts of fallen timber in this reach.

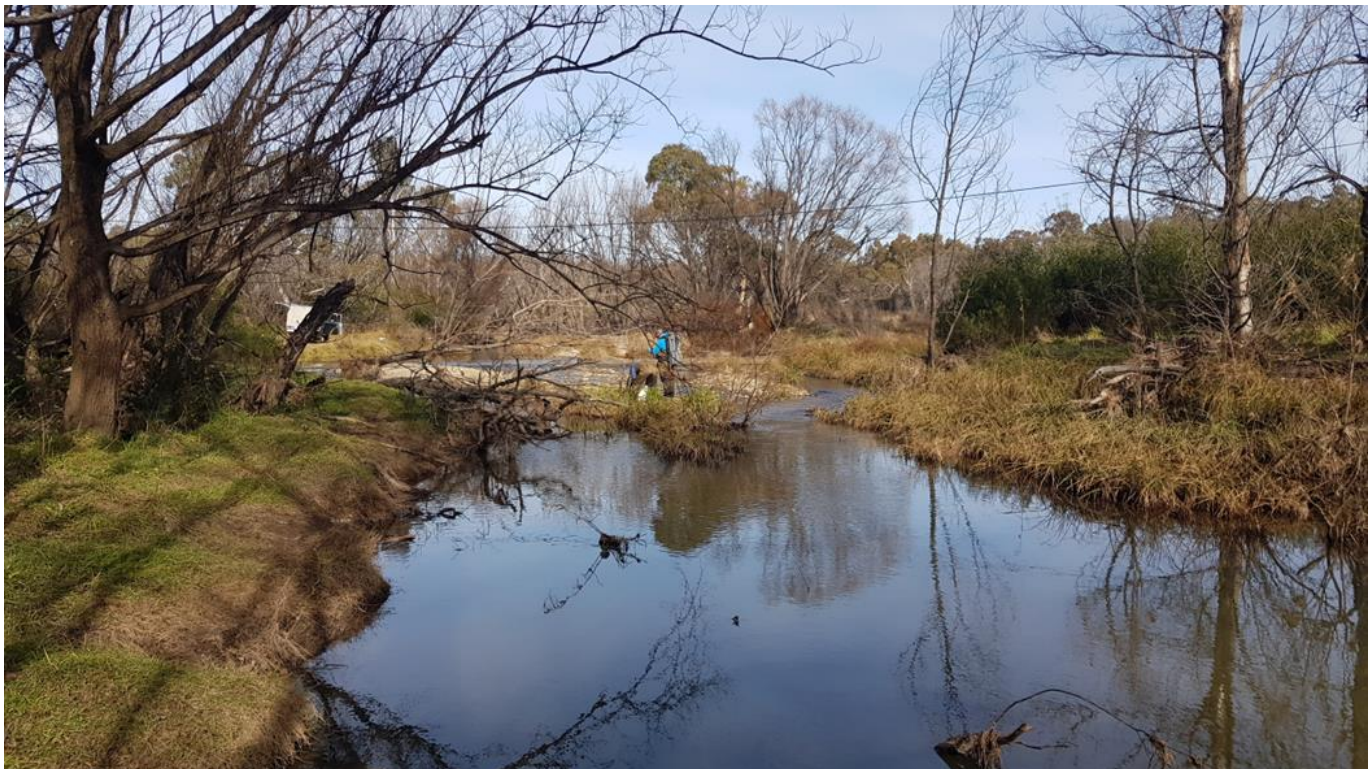
Bombay Creek at Hoskinstown Road crossing.

Description: This site occurs on the downstream side of the Hoskinstown Road crossing of Bombay Creek. This reach has a dense native and willow canopy.

Substrate Composition: Primarily sediment, with small amounts of cobble and submerged vegetation.

Other Structure: Large amounts of fallen timber in this reach.
